Manhole Inspection Summary

Manhole # S65Q__002MH

Insp Date: **5/12/08 9:31 AM**

Location Address: **1452 Broening Hwy.**

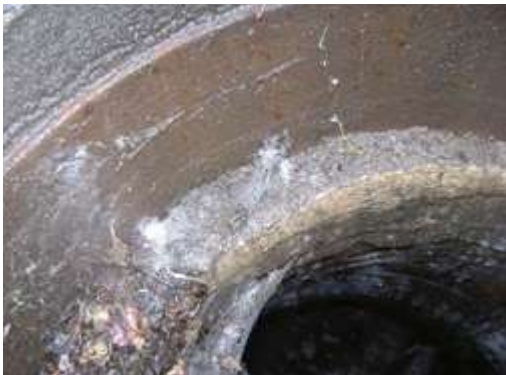
Defect 1

Frame Offset: **3** (in.) Condition: ☒ Sound ☐ Cracked ☐ Leaks

Offset frame

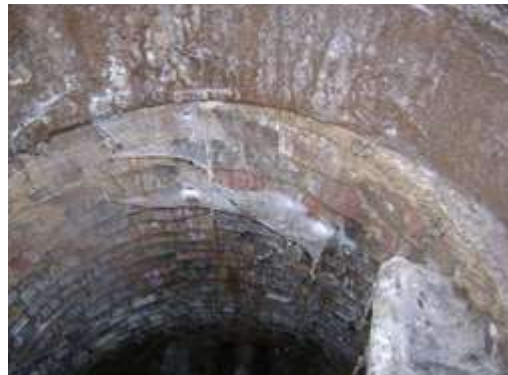
Defect 2

Condition: ☐ Sound ☐ Cracked ☐ Root Intrusion ☒ **Loose Brick** ☐ Deteriorated

Infiltration: ☐ None ☒ **Joint** ☐ Cracks ☒ **Mortar** ☐ Roots ☐ Wall

evidence of infiltration

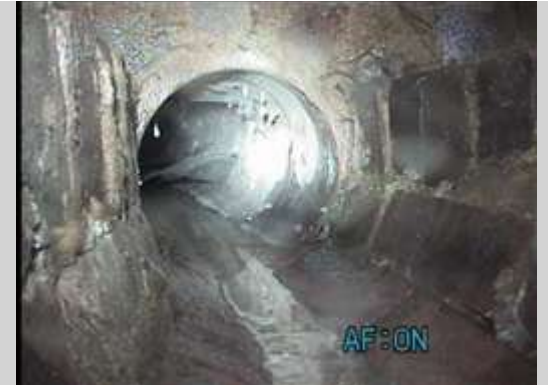
12 O'Clock Outflow

8 in. Circular Gravity Sewer
Pipe Out @ 12 O'Clock

Pipe Height: **8.4** (in.) Rod and Bar (Angled)
Pipe Material: **Clay** ☐ Pipe Lined
Invert Depth: **6.67** (ft.) Flow Characteristics: **Slow**
Deposits: ☒ None ☐ Mud ☐ Sludge ☐ Debris ☐ Grease
Silt Depth: (in.) Deposits Extent:
Infiltration: **None** Pipe Seal Cond: **Sound**

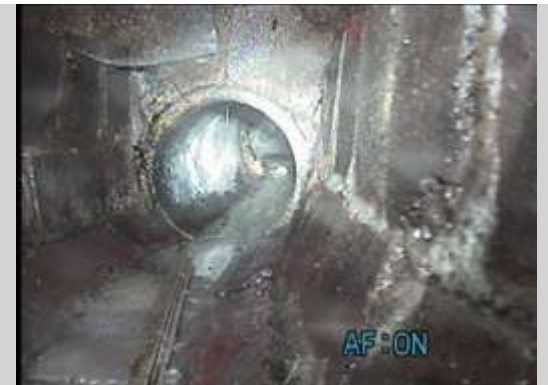
7 O'Clock Inflow

8 in. Circular Gravity Sewer
Pipe In @ 7 O'Clock

Pipe Height: **8.4** (in.) Rod and Bar (Angled)
Pipe Material: **Clay** ☐ Pipe Lined
Invert Depth: **6.50** (ft.) Flow Characteristics: **Slow**
Deposits: ☒ None ☐ Mud ☐ Sludge ☐ Debris ☐ Grease
Silt Depth: (in.) Deposits Extent:
Infiltration: **None** Pipe Seal Cond: **Sound**
